**Flood Control Project Maintenance
Levee Inspections**

Maintenance Issue Types Only, Levee Inspection Report By Mile - Spring 2017

Solano County Public Works Mellin Levee

Waterway	Bank	Unit Miles	Inspection Start/End	Inspector
Unit No. 01 Mellin Levee	Right	0.59	03/15/2017 03/15/2017	Richard Willoughby

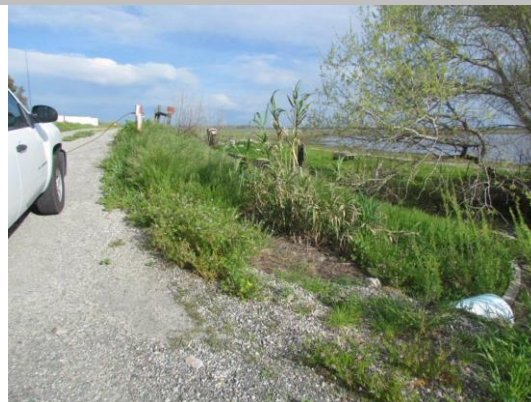
Photo 1 of 1 : SP_2017_NA0012_258_1_20170316_00010.jpg

LM Start	0.00	Rating **	M	Issue No.	1
LM End	0.28	Issue Type +	Ma	Location *	WS
Category	Earthen Levee			GPS Latitude/Longitude	
				Start	End
Item	Vegetation			38.174051 °	38.176920 °
				-121.674220 °	-121.677898 °
DWR ID	DWR_NA0012_01_s _ 2012_1				
Comment Code					
V1 : Control annual grass and weeds on the levee slopes and easements.					
Inspector Comment					
Control Arundo and other veg on waterside slope at the entrance to the levee.

Looking west at typical view of waterward slope.

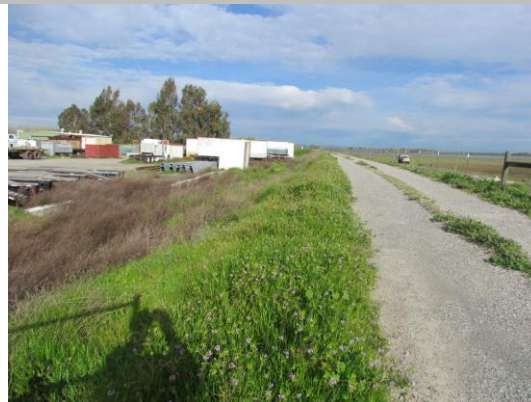
Photo 1 of 1 : SP_2017_NA0012_258_8_20170316_00011.jpg

LM Start	0.00	Rating **	M	Issue No.	8
LM End	0.28	Issue Type +	Ma	Location *	LS
Category	Earthen Levee			GPS Latitude/Longitude	
				Start	End
Item	Vegetation			38.174005 °	38.176920 °
				-121.674303 °	-121.677898 °
DWR ID	DWR_NA0012_01_s _ 2017_8				
Comment Code					
V1 : Control annual grass and weeds on the levee slopes and easements.					
Inspector Comment					
Control annual growth on landward slope.

Looking west at typical view of landward slope.

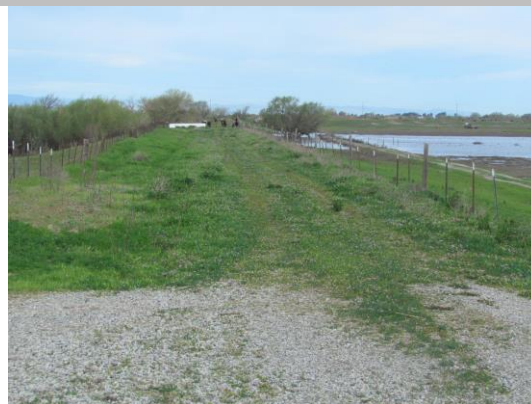
Photo 1 of 1 : SP_2017_NA0012_258_10_20170316_00012.jpg

LM Start	0.15	Rating **	M	Issue No.	10
LM End	0.59	Issue Type +	Ma	Location *	CR
Category	Earthen Levee			GPS Latitude/Longitude	
				Start	End
Item	Vegetation			38.175627 °	38.180044 °
				-121.676185 °	-121.681978 °
DWR ID	DWR_NA0012_01_s_2015_10				
Comment Code					
V1 : Control annual grass and weeds on the levee slopes and easements.					
Inspector Comment					
Control growth on crown roadway.

Looking west at growth on levee crown.

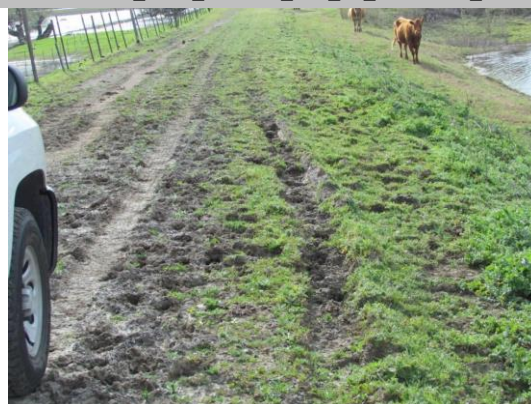
Photo 1 of 1 : SP_2017_NA0012_258_11_20170316_00013.jpg

LM Start	0.36	Rating **	M	Issue No.	11
LM End	0.51	Issue Type +	Ma	Location *	CR
Category	Earthen Levee			GPS Latitude/Longitude	
				Start	End
Item	Crown Surface / Depressions / Rutting			38.177672 °	38.179228 °
				-121.678847 °	-121.680865 °
DWR ID	DWR_NA0012_01_s_2017_11				
Comment Code					
C2 : Repair depressions or ruts in the crown or slope.					
Inspector Comment					
Repair ruts on levee crown.

Looking east at ruts on levee crown shoulder.

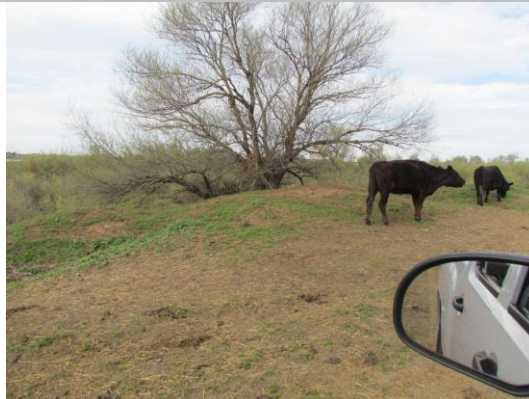
Photo 1 of 3 : SP_2017_NA0012_258_12_20170316_00014.jpg

LM Start	0.59	Rating **	M	Issue No.	12
LM End	0.59	Issue Type +	Ma	Location *	LS
Category	Earthen Levee			GPS Latitude/Longitude	
				Start	End
Item	Trim / Thin Trees			38.180062 °	38.180062 °
				-121.681993 °	-121.681993 °
DWR ID	DWR_NA0012_01_s_2015_12				
Comment Code					
T1 : Trim trees to at least five feet above ground level.					
Inspector Comment					
Untrimmed tree on landward shoulder and slope.

Looking southwest at untrimmed tree on landward slope (Spring 2017)

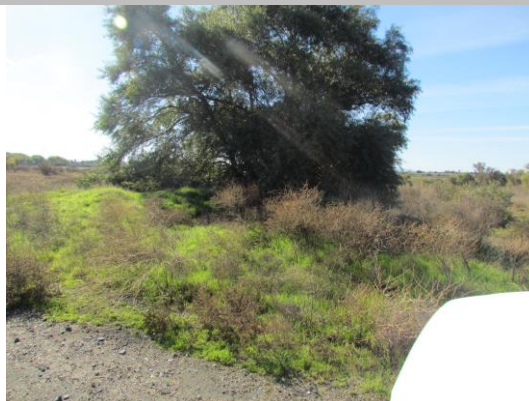
Photo 2 of 3 : SP_2017_NA0012_258_12_20170314_00008.jpg

Looking southwest at untrimmed tree on landward slope. (Fall 2016)

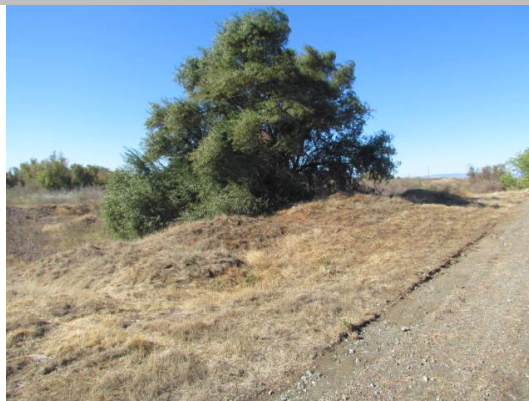
Photo 3 of 3 : SP_2017_NA0012_258_12_20170314_00009.jpg

Looking at untrimmed tree on landward slope fall 2015.
